Fire Risk Assessment

Langstone Conservative Club Ltd

Denvilles House
33 Emsworth Road
Havant
Hampshire
PO9 2SN

Date of Risk Assessment:	22nd May 2024
Site Type:	Small to Medium Places of Assembly
Client:	Langstone Conservative Club Ltd
Site Address:	Langstone Conservative Club Ltd Denvilles House 33 Emsworth Road Havant PO9 2SN
Unique reference:	FH169461716375600

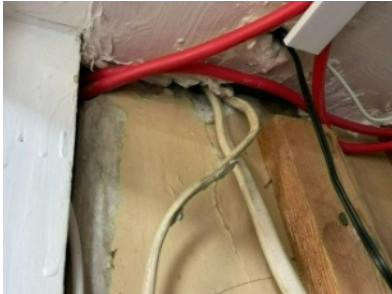
2.9 Are fire protected service risers, ducts and cupboards in a good state of repair and will they restrict the spread of fire and smoke?	✗ NO
All service risers, ducts and cupboards were inspected and the fire resistance was damaged or missing and requires fire-stopping.	
<div style="display: flex; align-items: center; gap: 10px;"> ! Significant Findings 3-6 MONTHS 1 </div>

Are fire protected service risers, ducts and cupboards in a good state of repair and will they restrict the spread of fire and smoke?

The ceiling in the electrical cupboard has a hole that should be fire-stopped, to prevent the spread of smoke and flames.

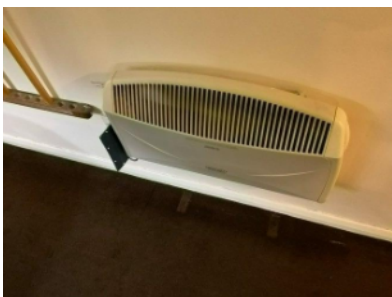
Wall-mounted electrical heaters are installed but are not subject to their own maintenance regime.

Are wall-mounted electrical heaters in use?

Wall-mounted electrical heaters are not covered by either PAT or a fixed wiring system and should be subject to additional maintenance in line with the manufacturer's requirements.

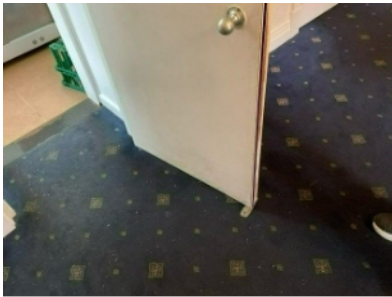
Some fire doors have been wedged open.

Where fire doors are wedged open, are automatic closers installed?

The following fire door to the dining room behind the kitchen should not be wedged open, It should either be kept closed into the latch at all times or an automatic door closer installed.
